LEVEL 1 REPLACEMENT RESERVE REPORT FY 2026

CAPE SAINT CLAIRE SWIM CLUB

REPLACEMENT RESERVE REPORT

April 11, 2025

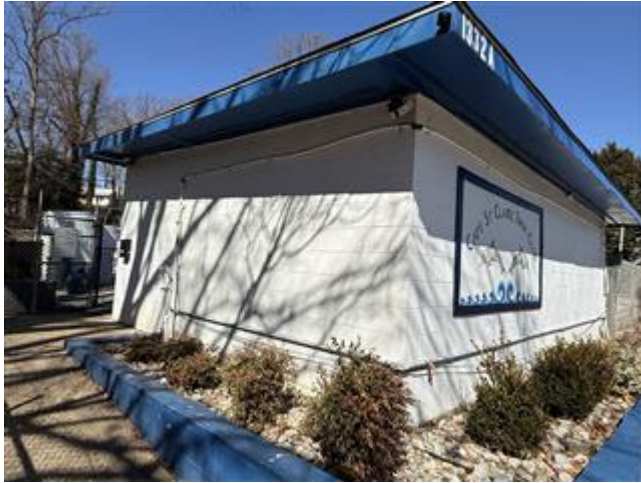
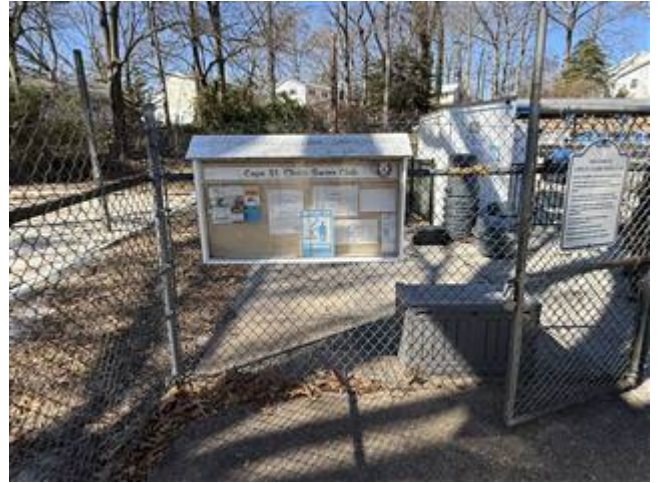
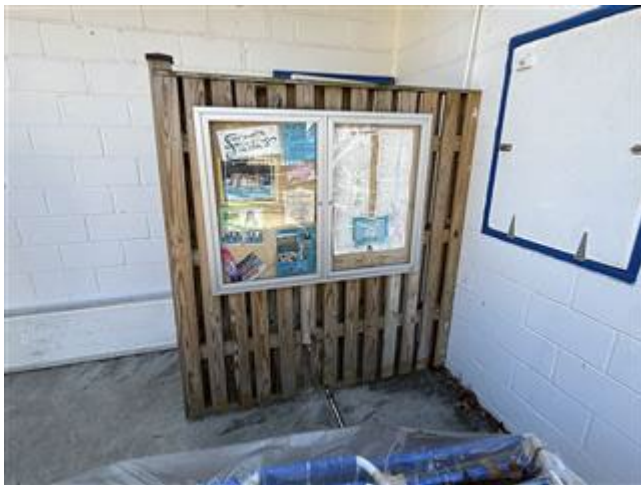
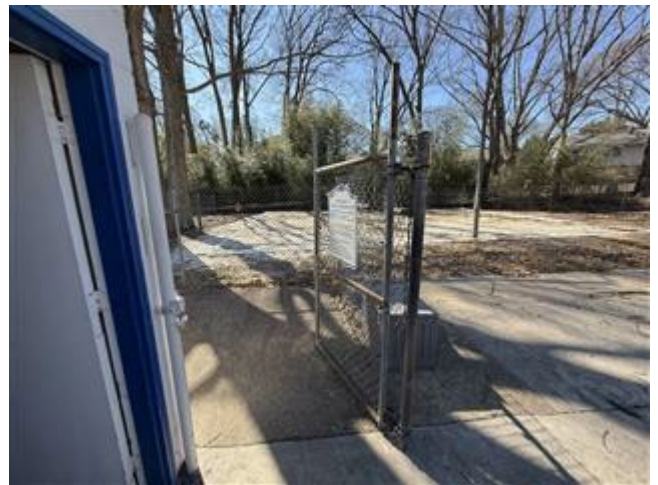
Entry Monument and Signage. The Association maintains community identification and announcement signs. The composite community identification sign appears to be in good condition. We noted weathering (tree mold) on the exterior announcement board roof. We recommend replacement every 10 to 15 years to keep the Club identification sign fresh and appealing. This study does not consider other small miscellaneous signs, and those should be replaced using other funds.

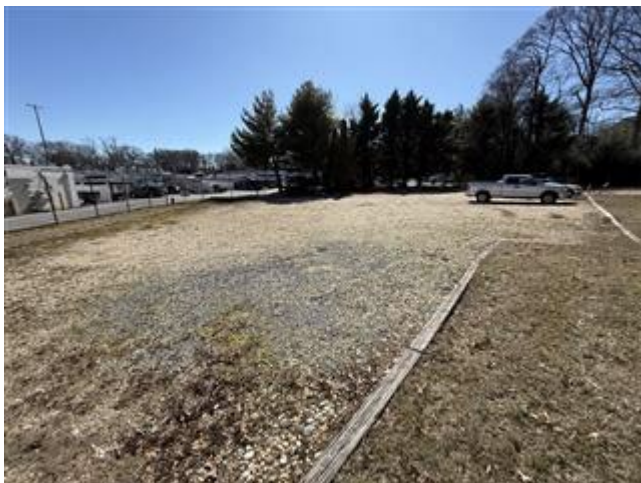
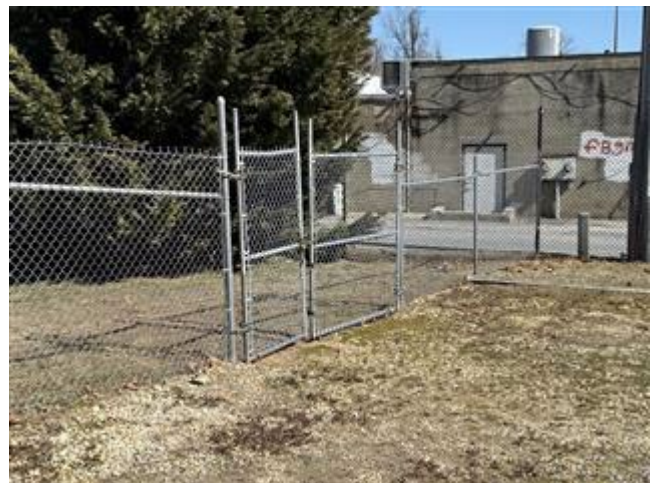
Gravel Parking. The community maintains a gravel parking area. The gravel parking appears to be in fair condition, with missing gravel and vegetation.

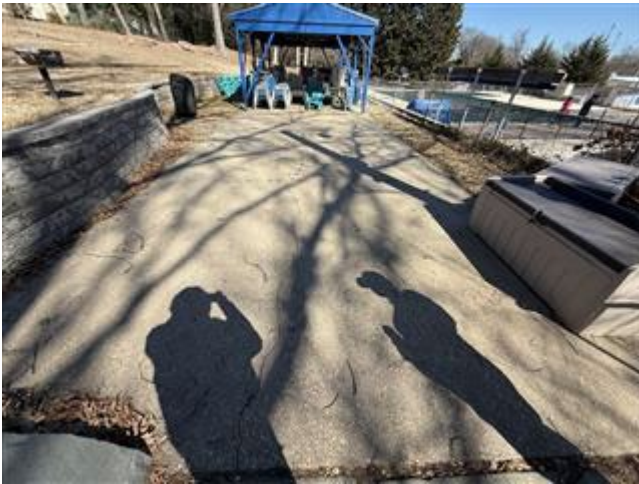
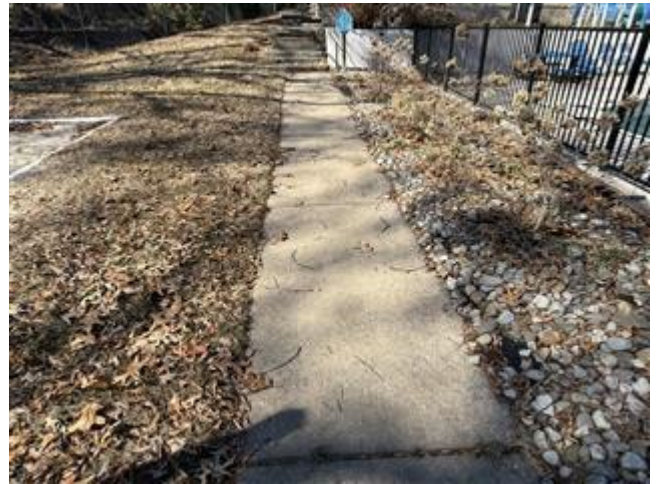
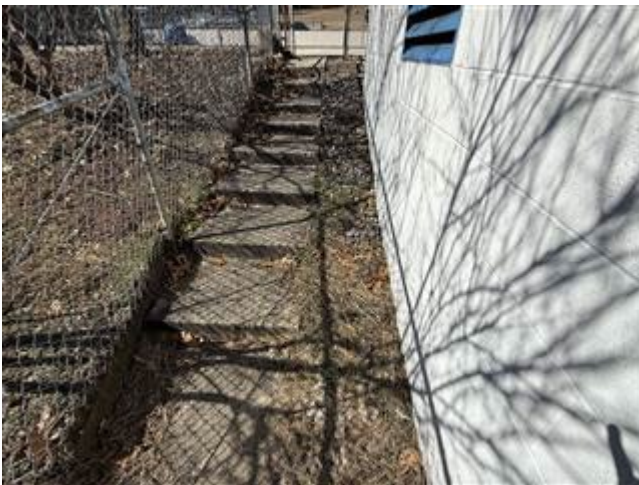
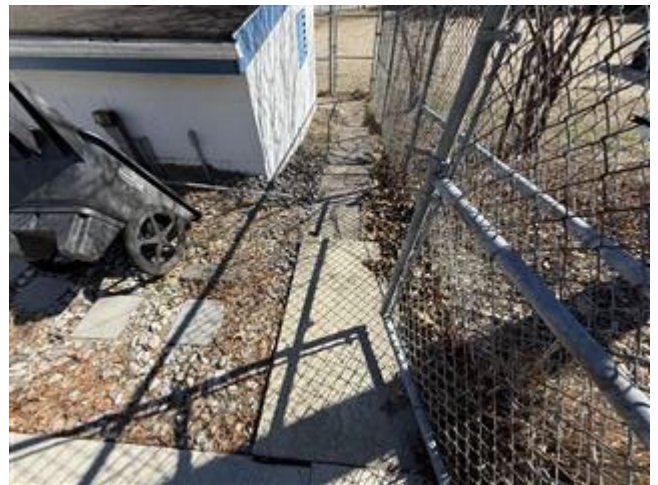
Concrete Work. The concrete work includes the community sidewalks, leadwalks, steps, patio, pavilion floor, and other flatwork. The overall condition of the concrete work appears to be fair, with a broken step leading to the main pump house. We noted a hairline crack running the length of the pavilion floor and patio, which should be caulked with urethane similar to the pool deck to prevent moisture freeze-thaw action from spalling the concrete and creating a tripping hazard.

Because it is highly unlikely that all of the concrete components will fail and require replacement in the period of the study, we have programmed funds for the replacement of these inventories and spread the funds over an extended timeframe to reflect the incremental nature of this work.

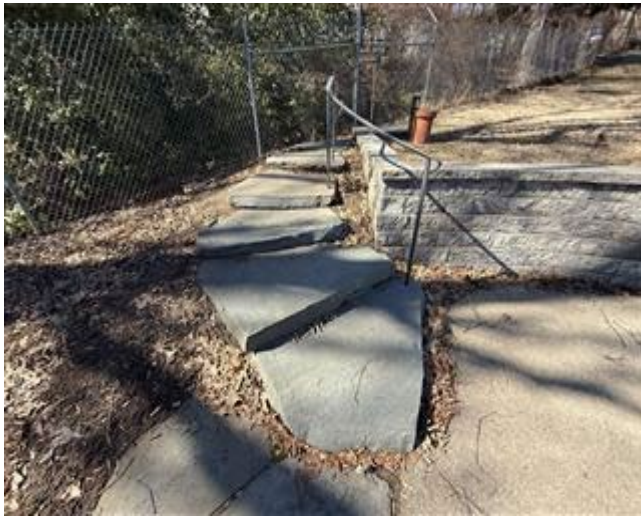
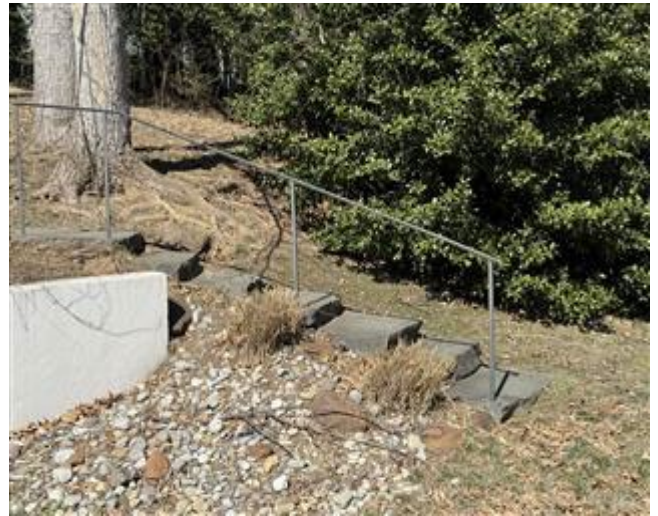
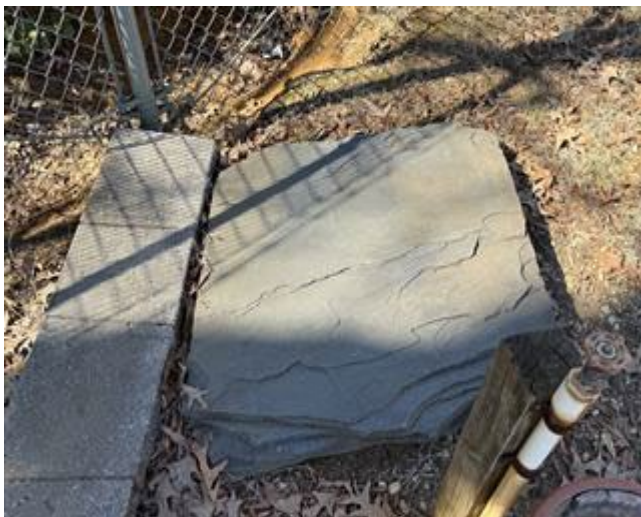
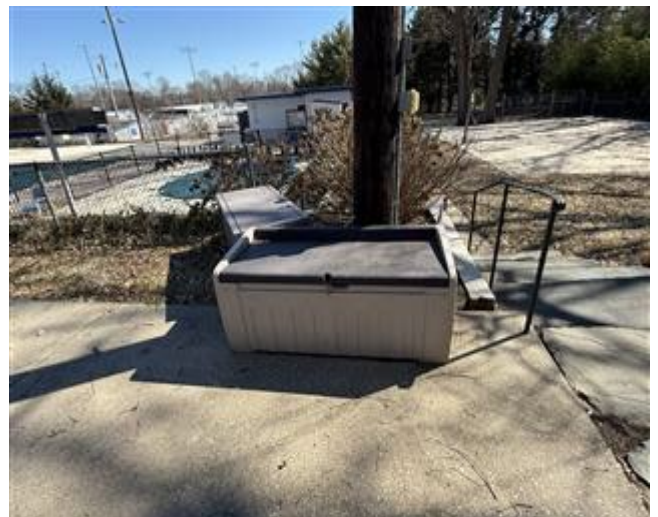
Stone Steps. The community has three sets of stone steps. Stone steps provide a solid, decorative, renewable surface to egress the upper recreation areas of the community. The overall condition of the stone steps appears to be good.

Stone steps have a service life of 30 years or more if the system is maintained consistently. Eventually, the system will require replacement with similar stone steps.

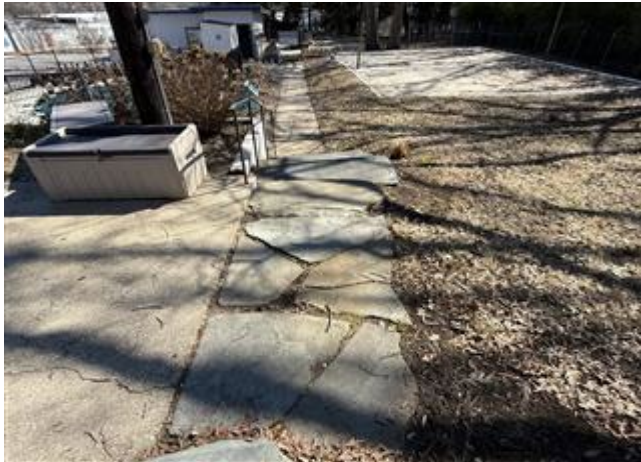
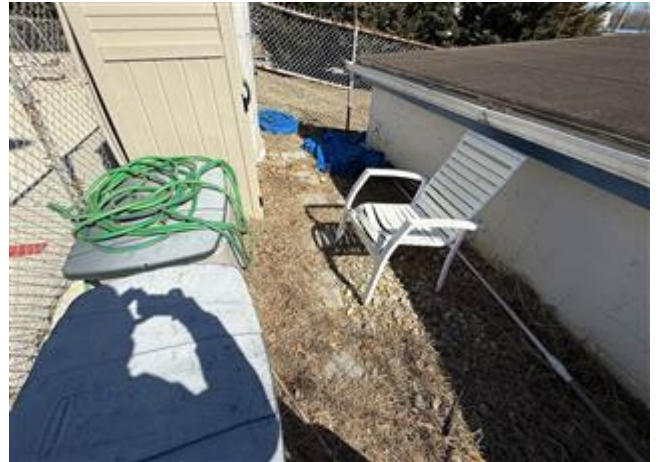
Flagstone (Stone) and Unit (Cement) Pavers. Flagstone and unit pavers provide a solid, decorative, and renewable surface that is part of the community's walkways. The overall condition of the unit pavers appears to be good.

Flagstone and unit pavers have a long service life of 50 years or more, provided they are periodically maintained. Eventually, pavers will require large-scale replacement, particularly when the walking surface becomes unsafe.

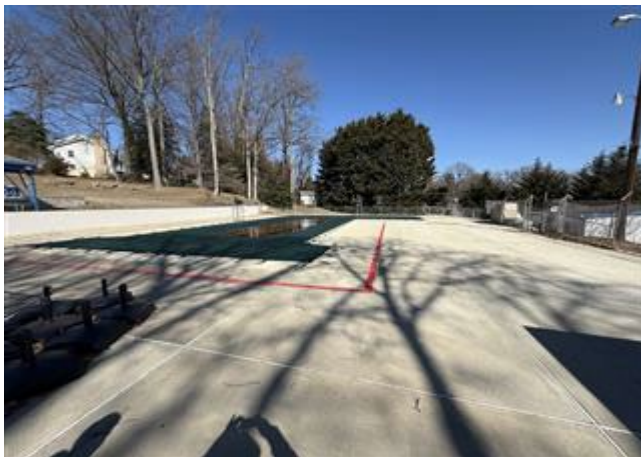
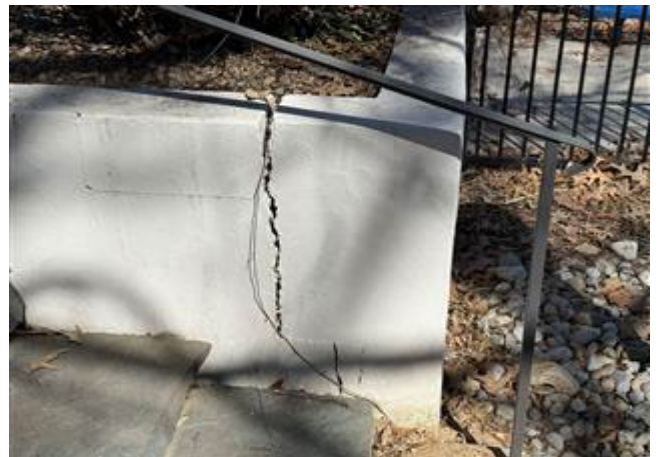
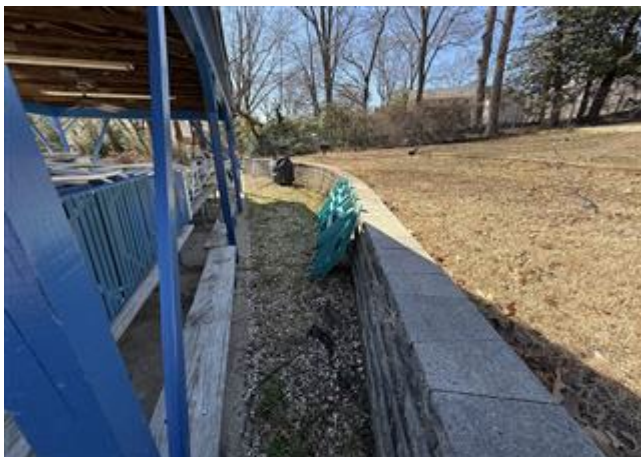
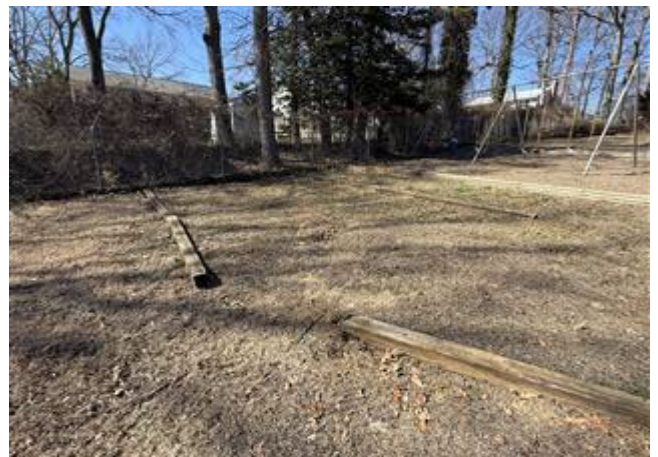
Retaining Walls. The Association maintains wood, block masonry, segmental block retaining walls, and wood landscape borders. The retaining walls appear to be in mixed condition, with open mortar joints in the block masonry retaining wall (light leaning), which was repointed and parged in 2024. The segmental block retaining wall appears to be in good condition. The wood landscape border, including the parking area, appears to be in mixed fair to poor condition.

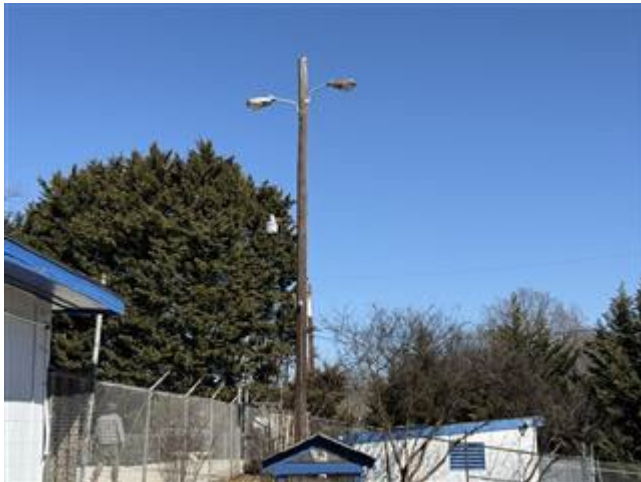
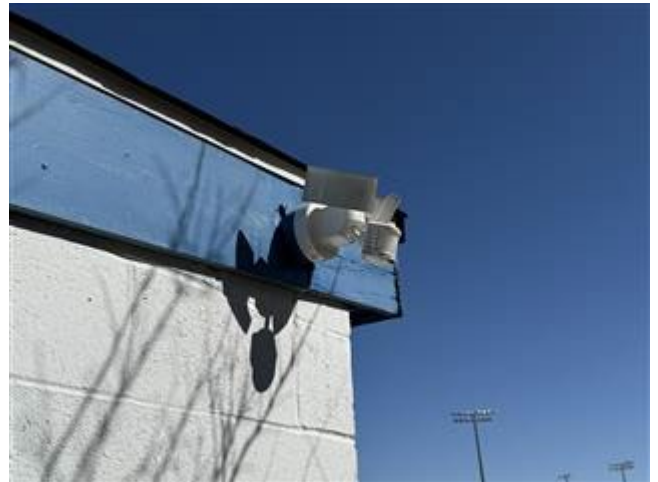
Site Lighting. The Association is responsible for operating the facility's pole and building-mounted flood lights, which appear to be in good condition.

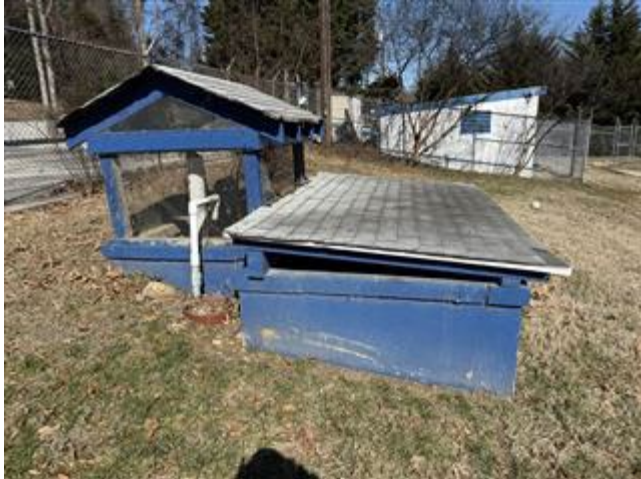
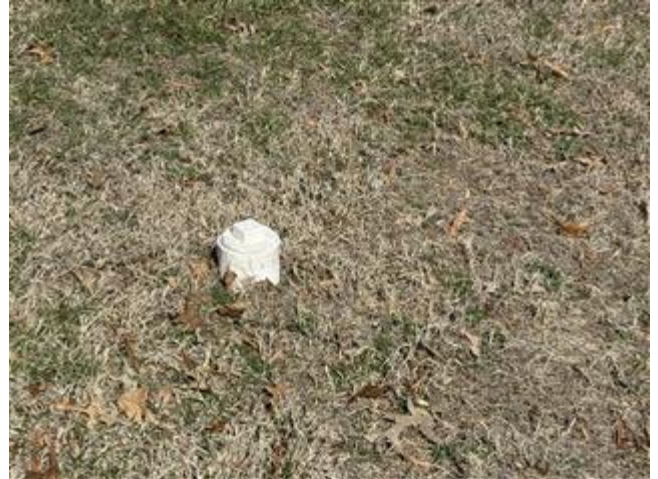
Underground Utilities. The Association is responsible for underground utility maintenance and replacement, including well and septic systems.

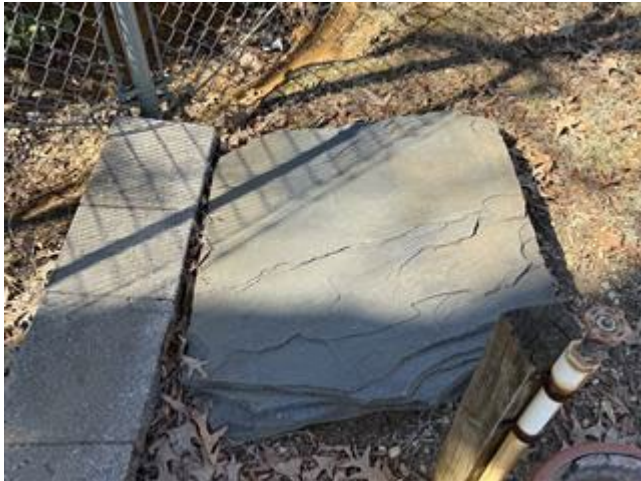
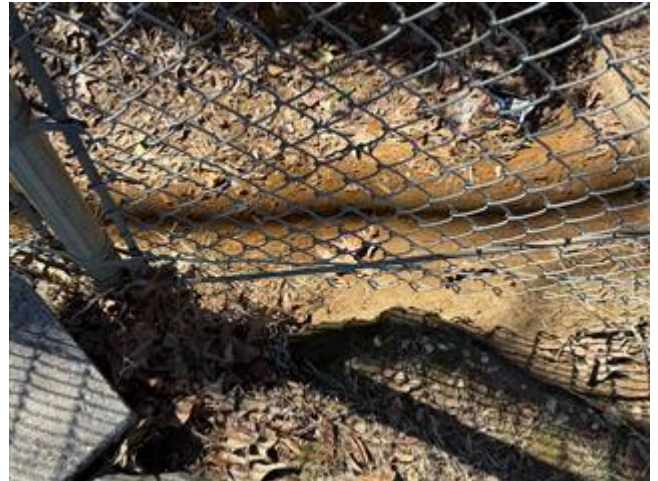
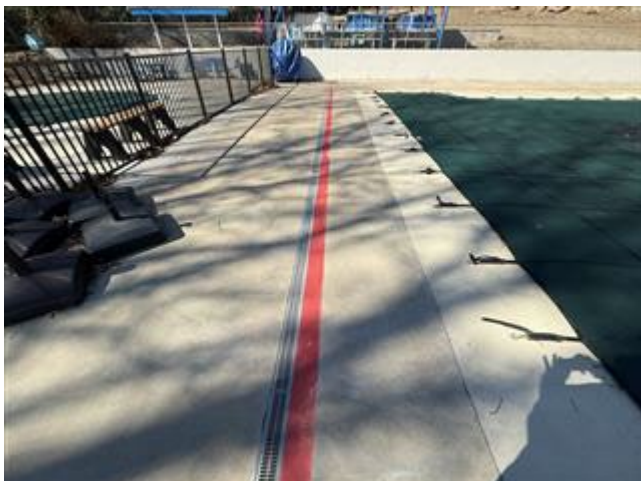
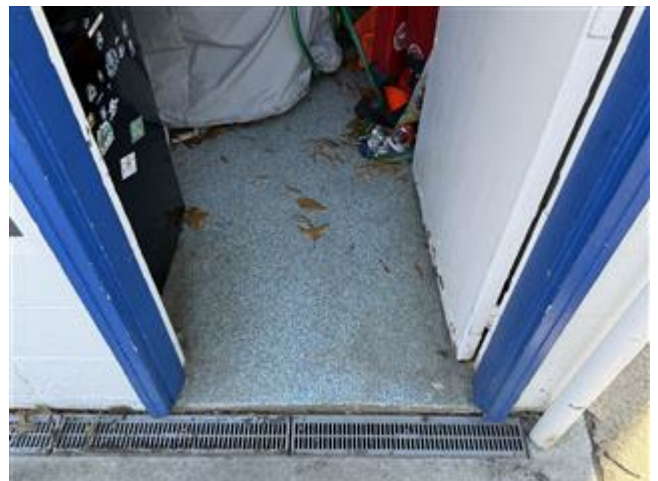
Stormwater Management. The community features stormwater management. The stormwater system consists of surface drainage, structured drainage, erosion control, and runoff. The overall condition of the stormwater management is poor. The Association reports that erosion along the southern fence line undermines the chain-link fencing posts, and the structured drainage from the trench drains makes the entrance landscape area saturated. The association may consider installing a dry well to mitigate the landscape saturation.

The community should maintain the stormwater system so that it functions as designed, limits erosion, and channels water to the drainage system. We have included funding in the Reserve Analysis for the installation of riprap along the fence line.

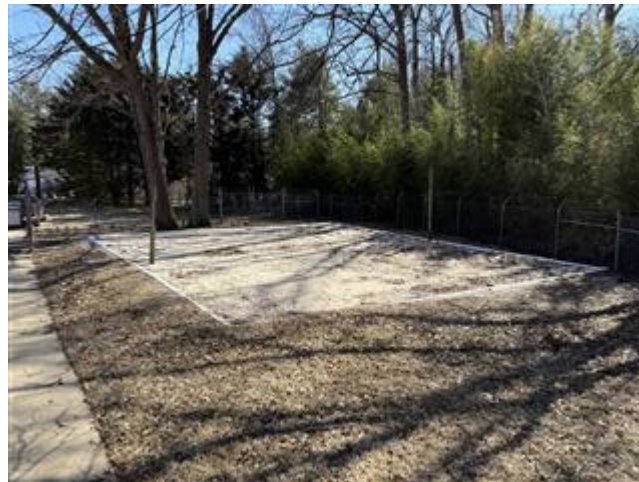
Volleyball Court. The Club has a sand volleyball court that appears to be in good condition. It has wood net posts and a PVC edge guard. The under-drain system, if any, was not observed.

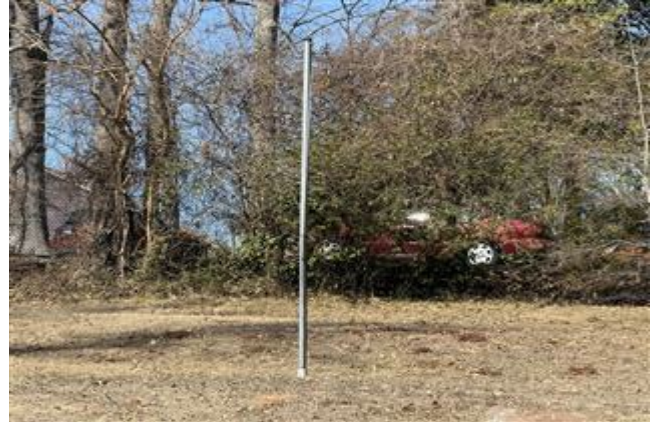
Tot Lots. The community maintains one tot lot. The tot lot includes a swing set, wood/synthetic borders, a wood chip surface, and a tether ball pole. The facility appears to be in generally good condition, with no noted wear, loose connections, cutting, entanglement, or falling, but with potential tripping hazards. The wood chip surface does not appear to be adequate. We noted that the swing set is installed on a slope.

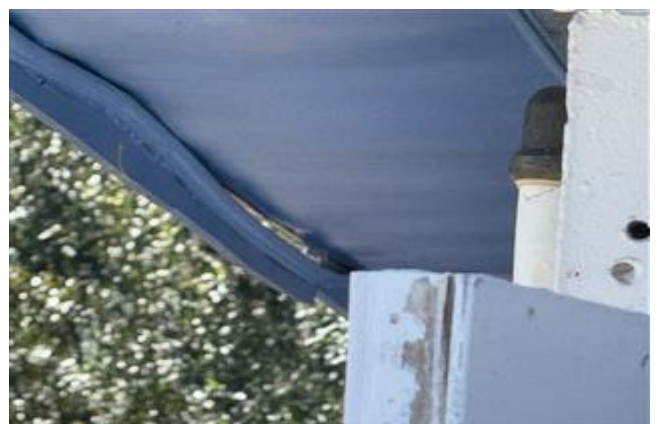
Siding and Trim. The buildings have wood soffits and trim, which appear to be in poor condition with damage and weathering. The wading pool pump house siding and trim appear to be in good condition.

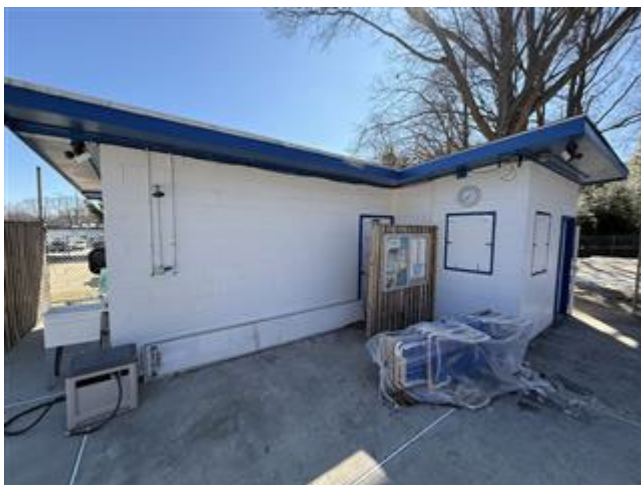
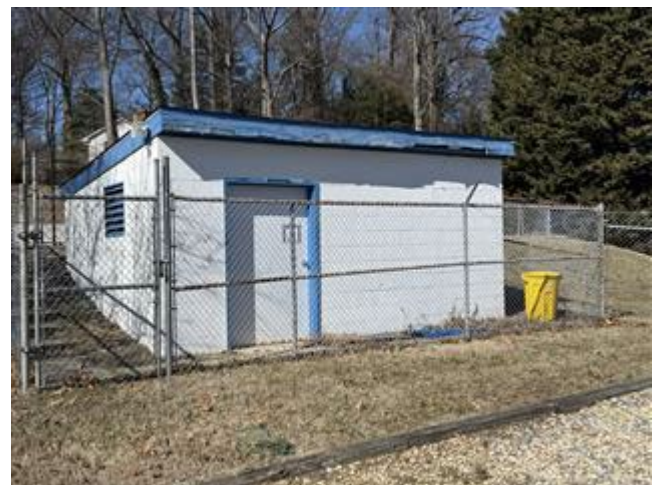
Masonry. The main buildings are constructed of block masonry, which appears to be in good condition.

In general, masonry is considered a long-life item and is therefore excluded from reserve funding. However, because weather and other conditions result in the slow deterioration of the mortar in masonry joints, we have included funding for repointing in this study. Repointing is the process of raking and cutting out damaged sections of mortar and replacing them with new mortar. Periodic repointing and local replacement of damaged masonry units will limit the damage done by moisture penetration. For this study, we assume that 10% of the masonry will require repointing every ten years after approximately 30 years.

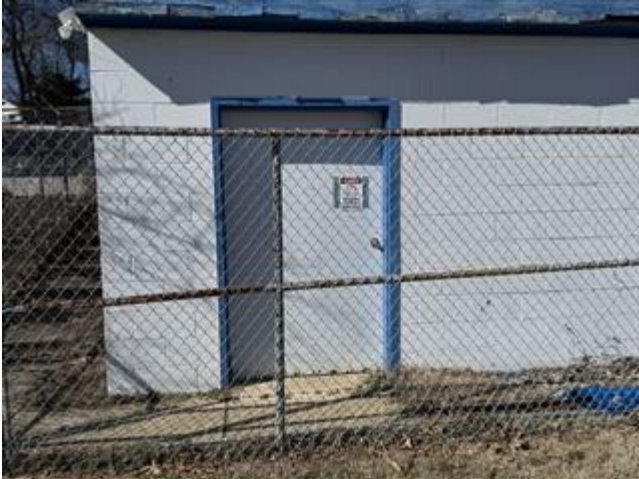
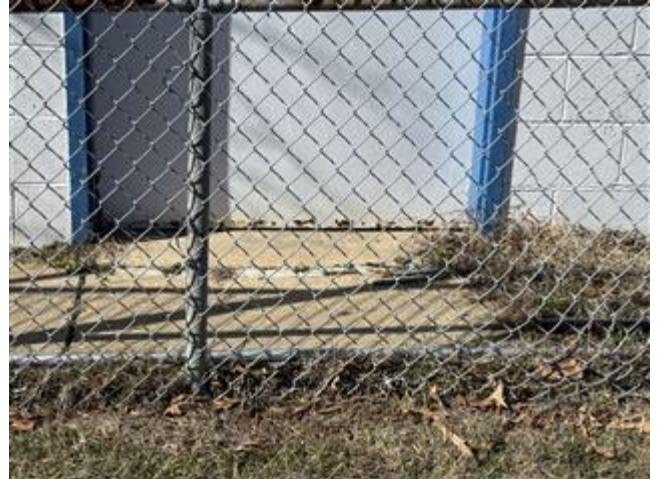
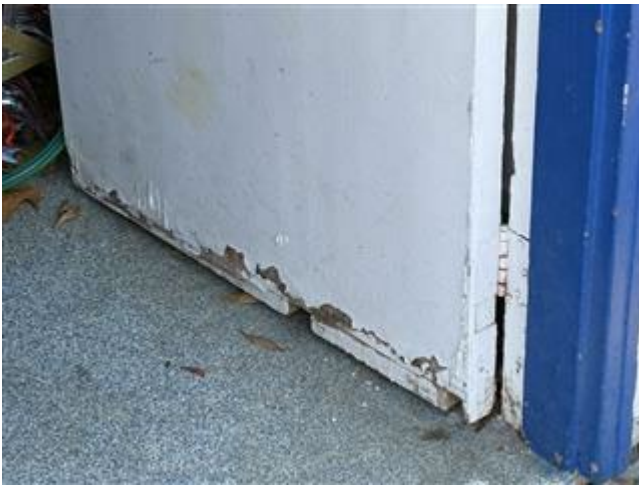
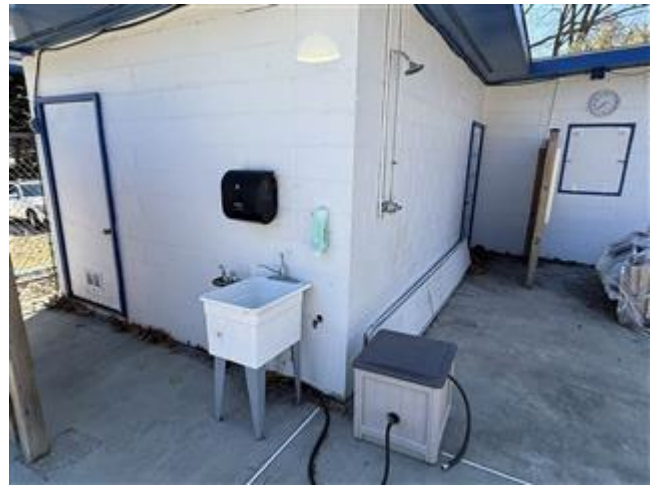
Windows and Doors. The Association is responsible for all of the facility's windows and exterior doors, which appear to be generally in fair condition. We noted corrosion on the main pool pump house door and frame. The pool manager's office door has deteriorated lower rails. The storage building's window and door appear to be in good condition.

In general, we recommend coordinating the replacement of these units with other exterior work, such as siding and roof replacements. The weather tightness of the building envelope often requires transitional flashing and caulking that should be performed in coordination. Warranties and advantages in 'economy of scale' can often result in lower overall replacement costs and more reliable results. Lastly, coordinated replacements offer the opportunity to correct initial construction defects and improve the effectiveness of details with improved construction techniques and materials.

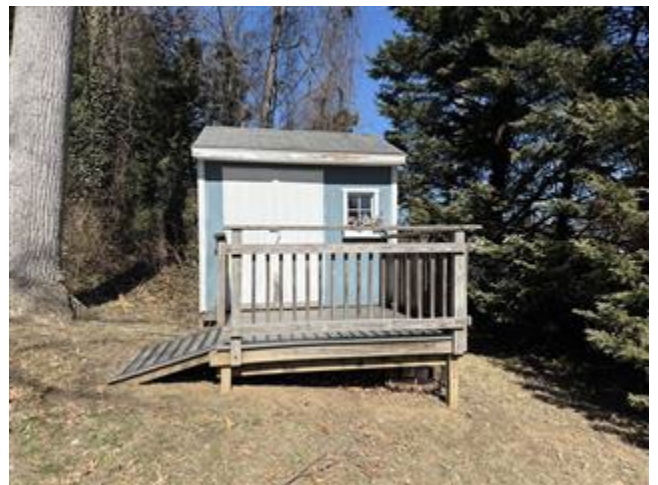
Decks. The Association maintains the wooden deck of the community storage building. The wooden deck structures, decking, and railings appear to be in fair condition with discoloration and weathering.

When installing new decking, a self-healing flashing membrane is recommended along the top and ends of all wooden horizontal structural members. Synthetic decking and railing systems should also be considered.

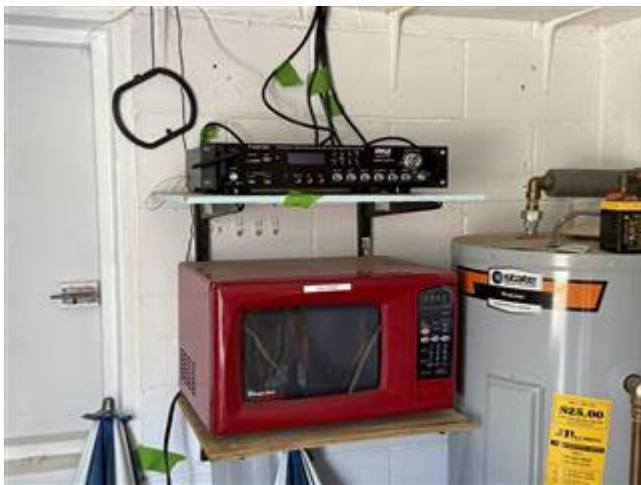
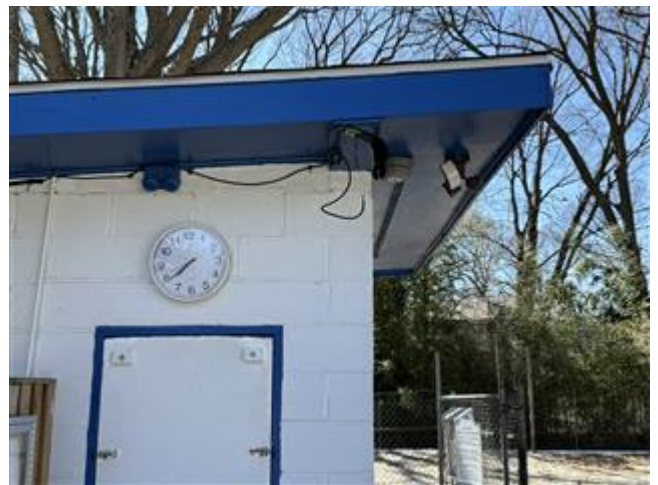
Audio System. The Club maintains an audio system that appears to be in good operating condition. The clubhouse's electronic systems also include a telephone panel and presumably wireless fidelity (WiFi). The speakers were removed at the time of the survey but are reported to be in good working condition.

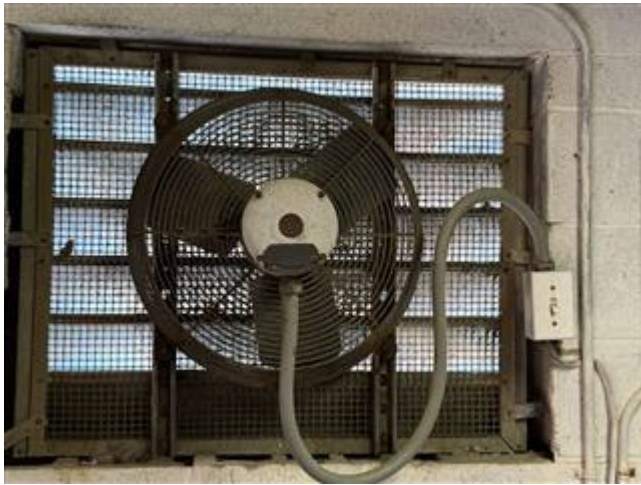
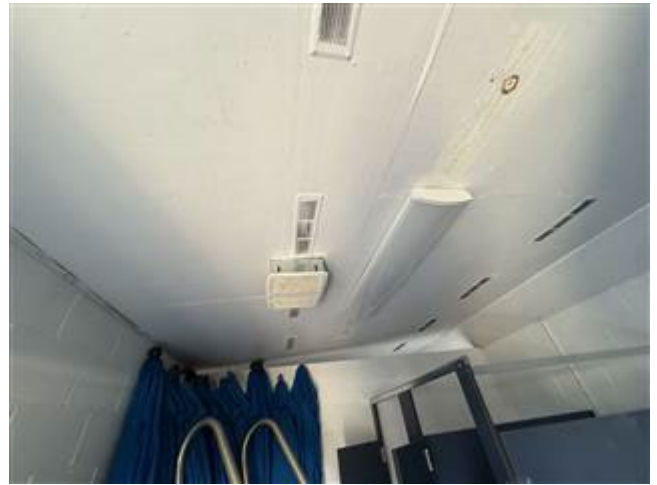
Ventilation Systems. The Association maintains ceiling and wall-mounted exhaust fans and metal louvers. The ventilation system is reported to be operating normally. Detailed inspection of ventilation systems is beyond the scope of the Reserve Analysis. Ventilation systems of this type have a service life of twenty years.

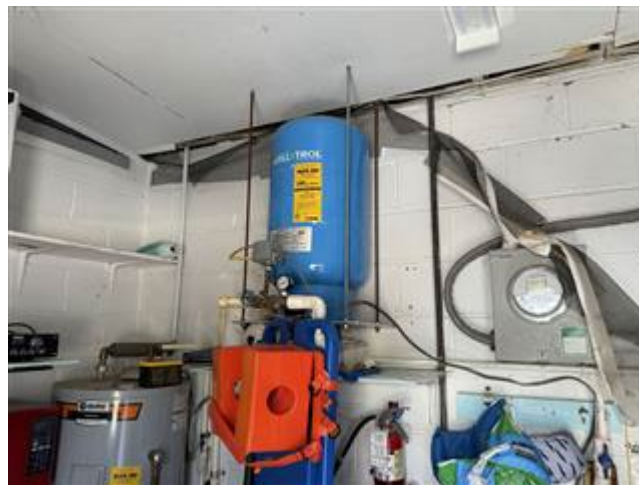
Tanks. The facility's well water system includes a water expansion tank. An expansion tank is designed to handle the thermal expansion of water as it heats up, preventing excessive water pressure and/or relieving the pressure surge of a well pump. If water pressure gets too high, it can damage valves in plumbing fixtures, joints in supply pipes, and the heater itself. Diaphragm expansion tanks have a service life of 7 to 10 years.

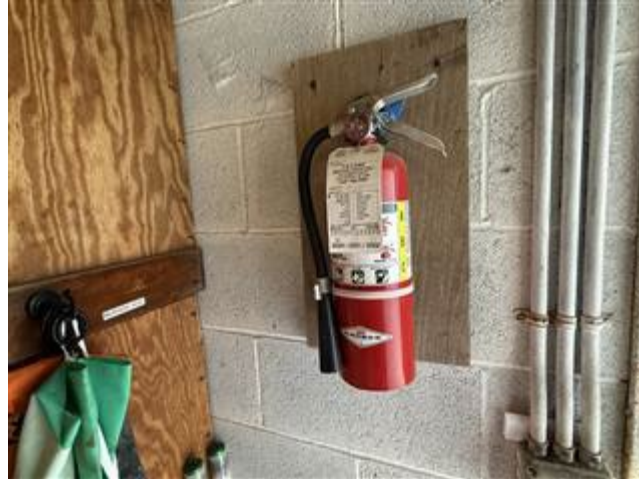
Fire Extinguishers. Portable fire extinguishers are often our first line of defense against small fires.
