LEVEL 1 REPLACEMENT RESERVE REPORT FY 2026

CAPE SAINT CLAIRE SWIM CLUB

REPLACEMENT RESERVE REPORT

April 11, 2025

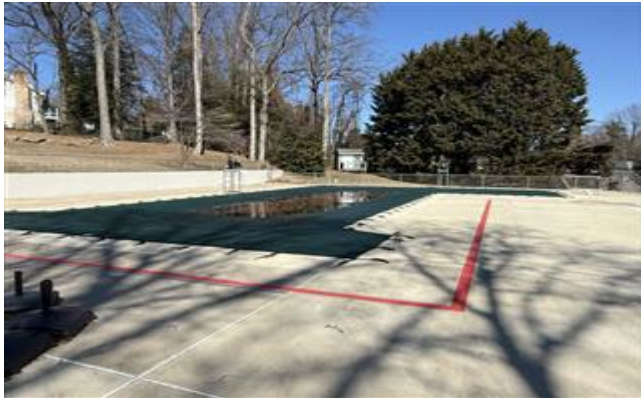
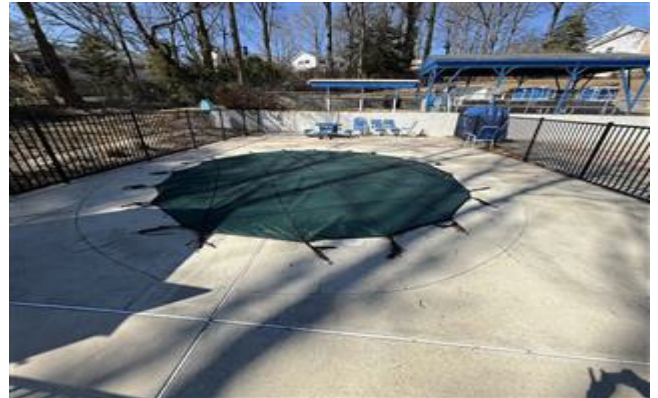
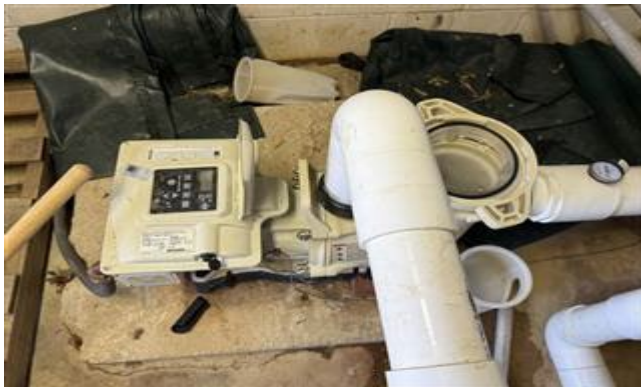
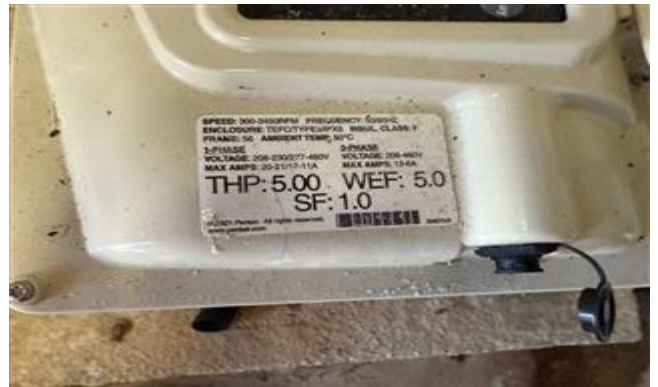
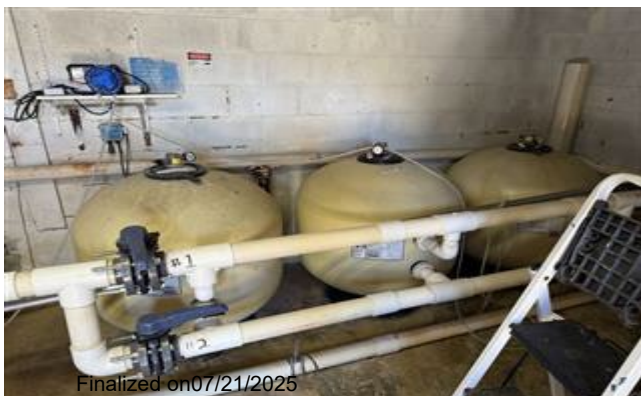
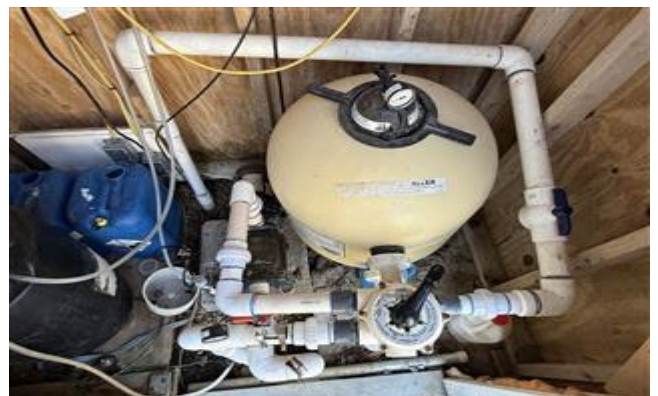
- Coping. The pool is edged with precast cement coping. The coping is reported to be in good condition.
- Pump and Filter System. The filter system appears to be in good operating condition. Furnishings. The pool furnishings include lounges, chairs, tables, umbrellas, and umbrella stands, which appear to be in good condition and are replaced as needed.

- Pool Fence. The swimming pool is enclosed by a metal and chain link fence that appears to be in good condition.

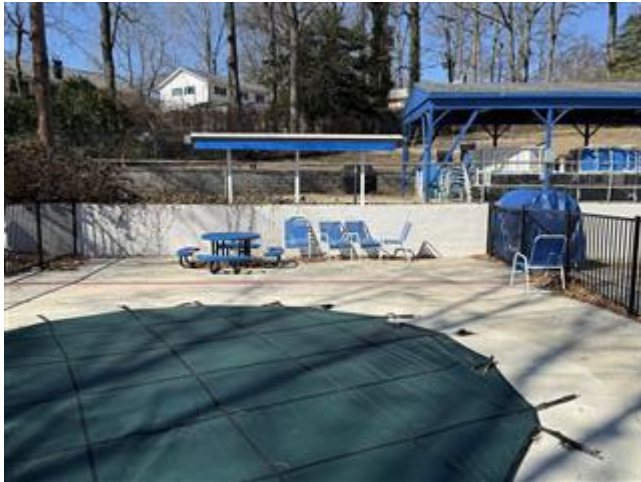
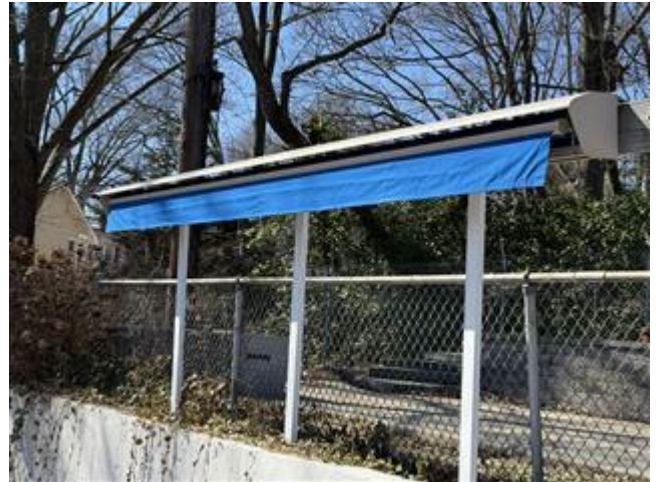
Canopy/Awning. The overall condition of the manually retractable canopy/awning appears to be good, and the metal framing appears to be in good condition. We have assumed a service life of 5 to 10 years for the fabric cover and 20 to 30 years for the metal framing.

To prolong the useful life of the fabric awning, we recommend periodic cleaning and the application of an appropriate sealant.

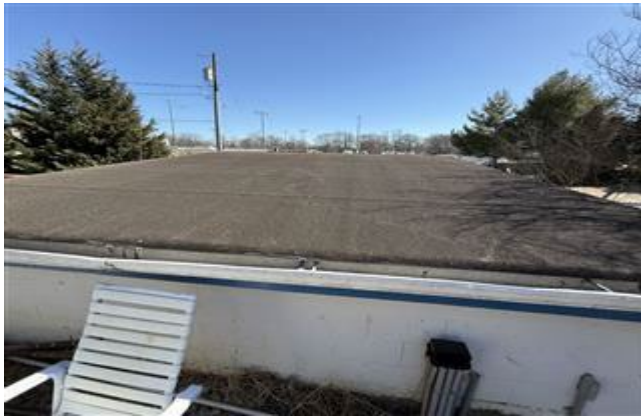
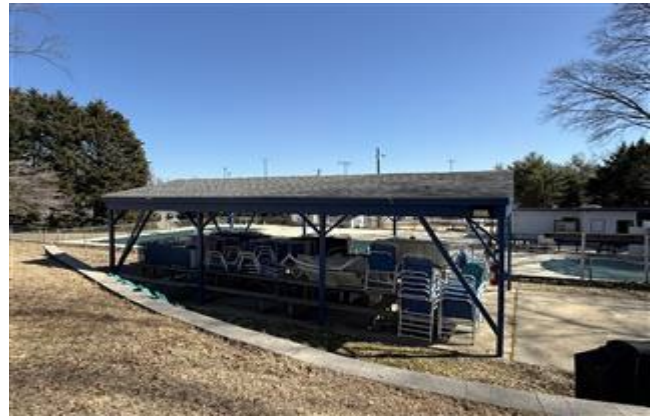
Building Roofing. The Club's buildings have flat and asphalt shingle roofs, which appear to be in mixed fair to poor condition.

Access to the roof was not provided during the site visit, and all roofs were observed from the ground.

Annual inspections are recommended, with cleaning, repair, and vegetation mitigation performed as needed. Contractors and personnel should perform access, inspection, and repair work with the appropriate access equipment experienced in the roofing types used for the facility.

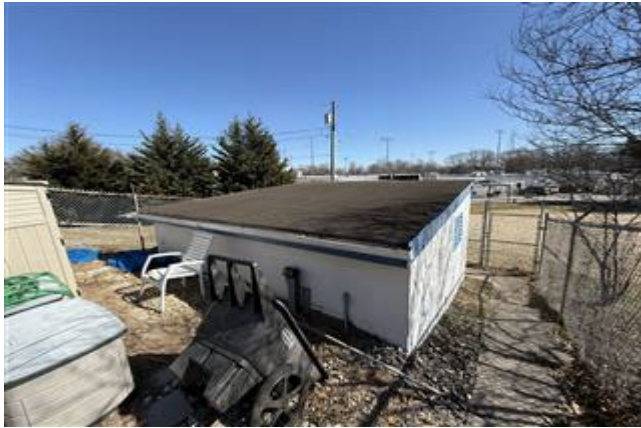
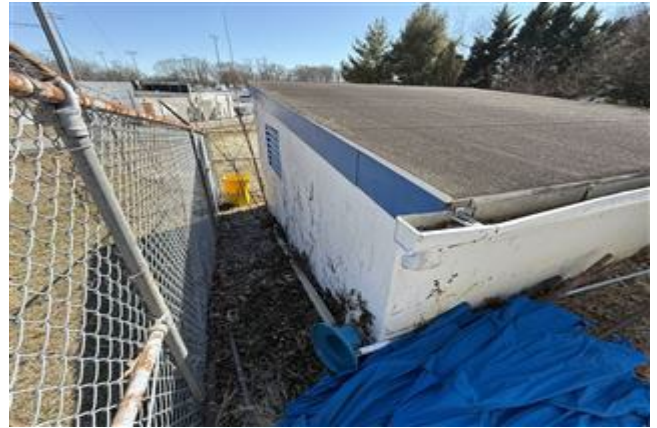
Gutters and Downspouts. The main pool pump house building has aluminum gutters and downspouts. The gutters and downspouts appear to be in fair condition, and we noted that the downspout was disconnected and lying on the ground.

Only a limited number of roof sections have gutters and downspouts installed. This lack of gutters and downspouts contributes to the deterioration of the siding, decks, windows, exterior doors, and unit stairs. We also believe that the lack of gutters and downspouts can contribute to erosion and foundation problems.

We recommend installing gutters and downspouts on all buildings and extending the discharge from the downspouts at least ten feet away from the foundations.

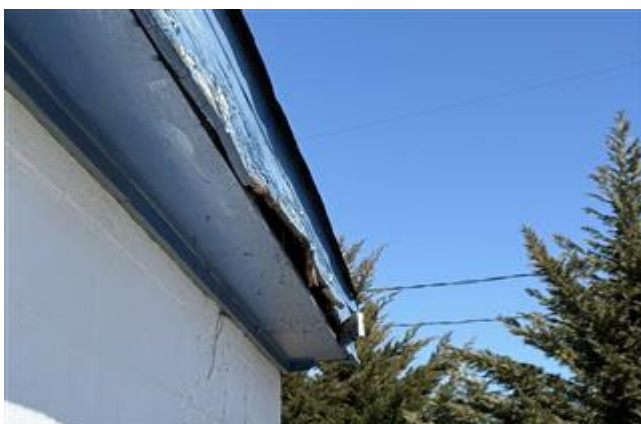
Siding and Trim. The buildings have wood soffits and trim, which appear to be in poor condition with damage and weathering. The wading pool pump house siding and trim appear to be in good condition.

Wooden exterior materials are typically repaired as needed during normal painting cycles. Painting cycles for wooden exteriors vary between five and ten years, depending on the wood grade, the materials' quality, and the finish work. In this study, we have modeled for an incremental wood material replacement to coincide with the painting cycle of the facility.

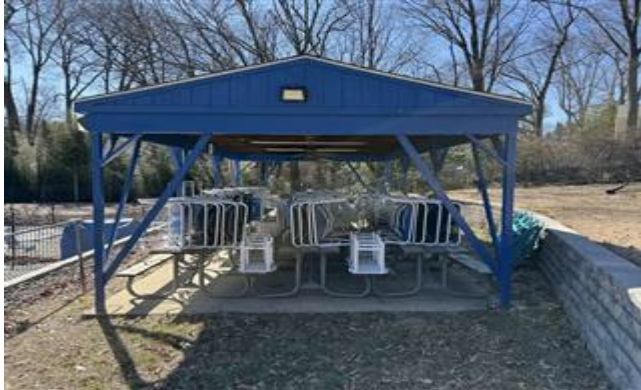
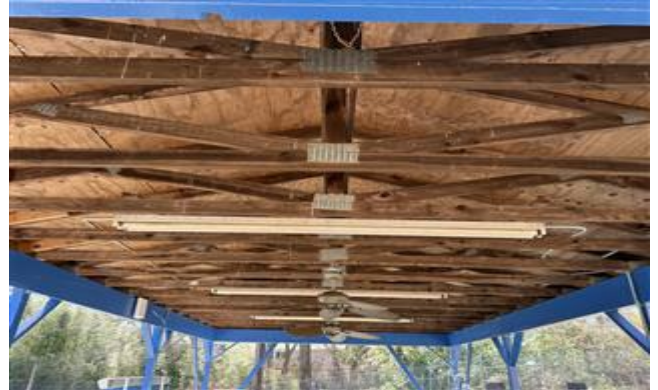
Pavilion. The Association maintains a wood pavilion with a concrete floor covered with asphalt shingle roofing. The roof, concrete slab, and pavilion structure appear in good condition. The rate of deterioration of the wood components of the pavilion will vary with the level of maintenance performed on those components as well as the exposure of the pavilion to the elements. Pavilions of this type can be expected to have a service life of 40 years. The concrete components are included in the total concrete flat-work line item.

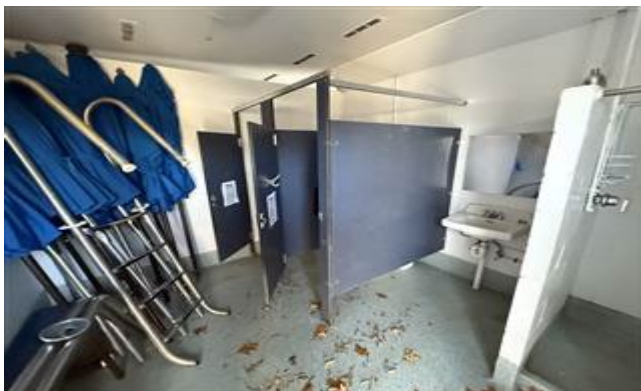
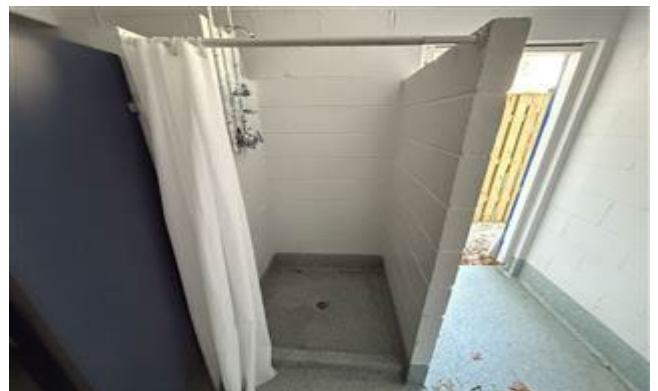
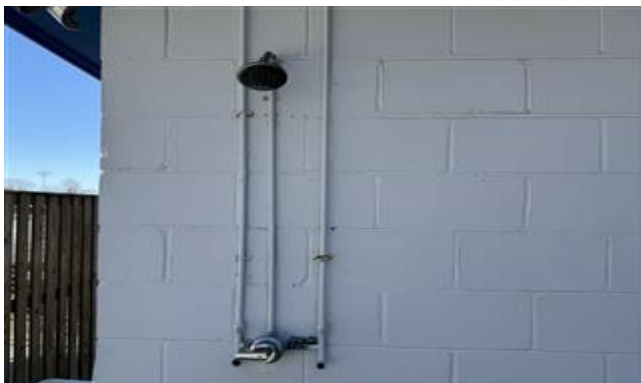
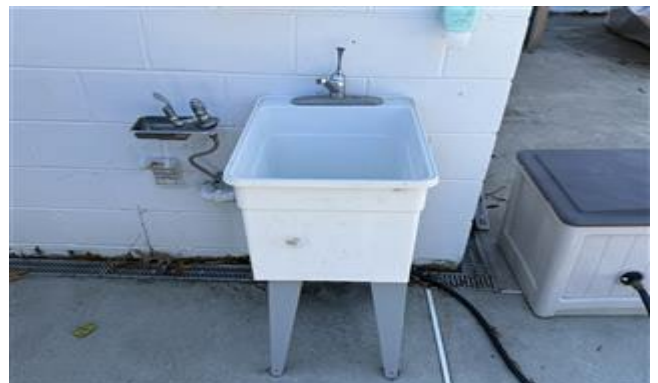
Locker Rooms. The locker rooms for the swimming pool are located in the guardhouse. The overall condition of the locker rooms appears to be good. Listed below are the major components of the locker rooms:

- **Floor Coating.** The floor coating in the locker rooms appears to be in good condition.
- **Light Fixtures.** Ceiling-mounted light fixtures provide illumination. The fixtures use compact fluorescent lamps. The fixtures appear in good working condition but were not on during the survey. Fixtures of this type have a typical service life of 25 years.
- **Shower and Restroom Fixtures.** All shower and restroom fixtures appear to be in good condition. We have assumed a service life of 20 years for the fixtures and that all fixtures will be replaced simultaneously as part of a general restroom renovation.

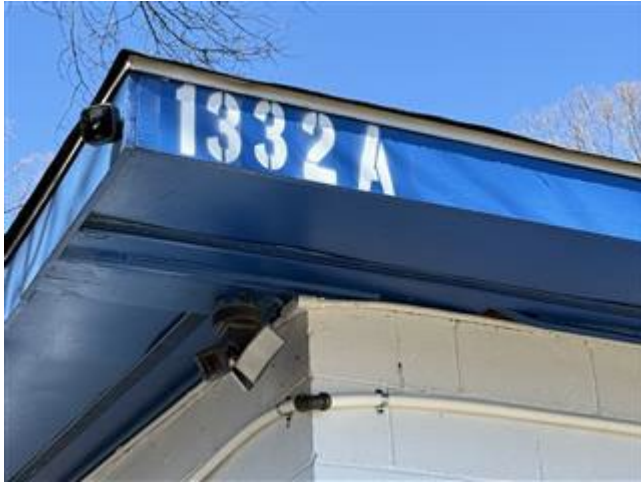
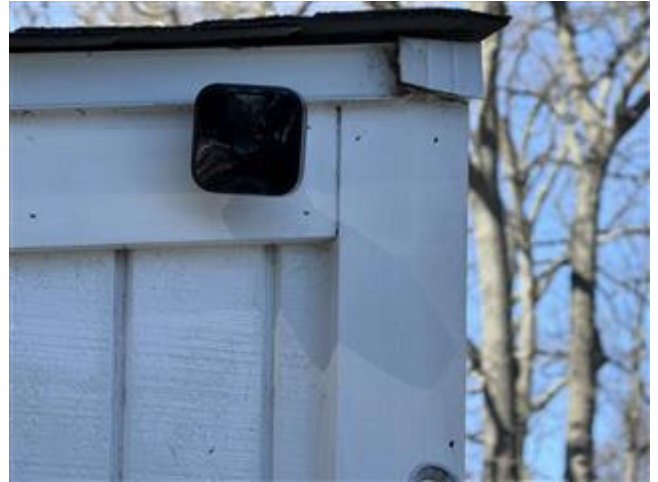
Security System. The Association maintains a security surveillance system to monitor community access. The building has a video-based security system with cameras installed at various locations in and around the buildings. The system appears to be of the Internet Protocol (IP) type and does not have a standalone recorder.

The service life for systems of this type is 15 years. While many of the system's components may function well beyond that point, the community will experience difficulty obtaining replacement parts and service for the system. Most manufacturers do not support hardware or software beyond this timeframe.

We have provided an estimate of the approximate replacement cost based on our experience with other communities of similar size and our inspection of the visible components while on site. We have programmed funds to replace the inventory every 5 years.

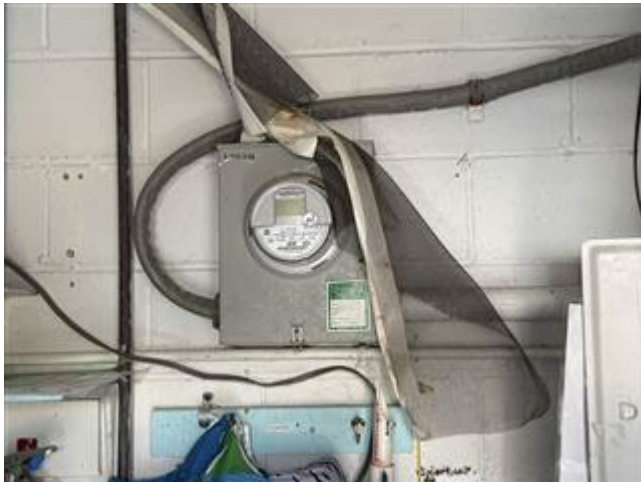
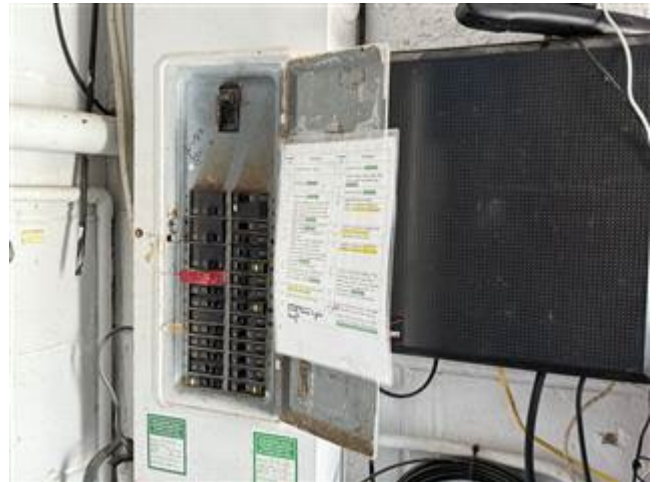
Electrical Distribution Panels. The building has an electrical distribution panel located in the pool manager's office. The panel separates the buildings' electrical power feed into separate circuits while providing protective circuit breakers for each circuit. The panel dates to the original construction of the building and has a rated service life of 50 years or more.

The overall condition of the distribution panel appears to be good. As the distribution panel ages, obtaining replacement parts can be expected to become more difficult. The Association must replace some existing panels when parts are no longer available. We have included funding in the Reserve Analysis for the distribution panel replacement.

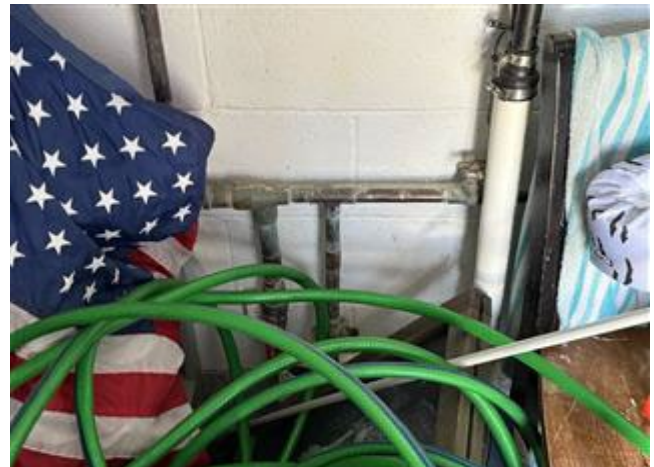
Building Piping. During our site visit, we noted cracked or leaking pipes, and broken pipes are being reported. Copper water supply pipes have been used throughout the facility.

Once the Club connects to the City water system, note: as a result of changes in water chemistry, brought on by federal clean water legislation, piping has been developing pin-hole leaks, which can lead to higher maintenance costs and a shorter than normal service life. For further information about the problem and research that is being conducted, please see the WSSC link on our website at <http://mdareserves.com/resources/links/building-system>. In addition, in some cases, the pipe and fitting materials are of poor quality, and pin-hole leaks have been reported in as little as three years.

Because of these problems, the facility's piping will require replacement at some point in time. As a less expensive alternative to the extremely costly work of re-piping a building, systems have been developed to clean and epoxy-line the interior surfaces of these, including other types of pipes. In addition, new pipe materials are on the market.

To gain a better understanding of the condition of this facility's pipes and water supply lines, we recommend having an expert evaluation of the piping performed. This evaluation should provide an estimation of the remaining useful life of the piping systems, the condition of the water supply, and recommendations for a replacement to maximize the remaining useful life of this facility's piping systems.

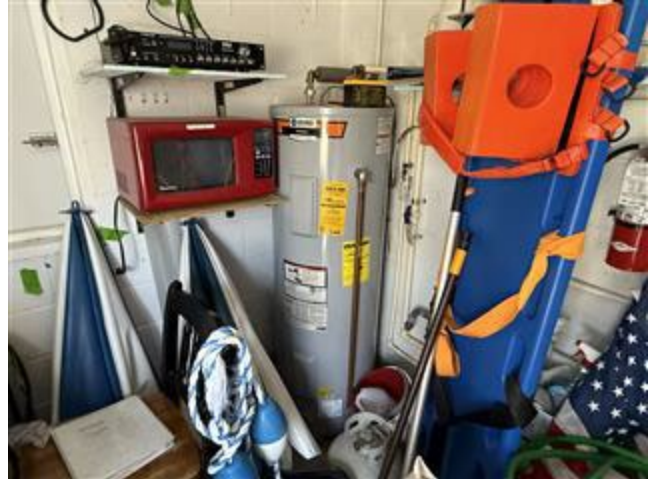
Water Heater. The Association maintains an electric storage water heater that appears to be in good condition. Water heaters have an expected useful life of 15 years.
